# COLLISION REPAIR INFORMATION

TITLE: QUARTER PANEL SECTIONING  
SECTION: EXTERIOR BULLETIN # 183  
MODELS: 2013- SCION FR-S  
DATE: DECEMBER 2012

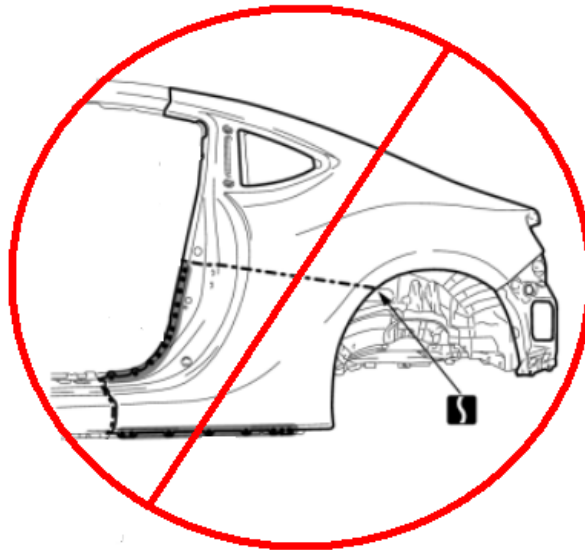
The 'Quarter Panel Sectioning' procedure shown below referred to as "Cut-P" "Small Section", **has been determined to be an unacceptable repair procedure** by the conditions provided below.

**NOTE:** The P-Cut Small Section replacement procedure may lead to one or more of the following unacceptable conditions:

- Excessive panel warping
- Extensive corrosive hot-spots from butt welding
- Excessive use of body filler materials
- Reduced repair quality leading to a detectable repair
